**Title: QUALITY AUDIT  
INCLUDING ROAD SAFETY AUDIT (Stage 1)  
For;  
Proposed Residential Development and Road Upgrade,  
Boherboy, Saggart, Co. Dublin.**

**Client: Pinnacle Consulting Engineers.**

**Report reference: 1151R01**

**VERSION: FINAL (February 2022)**

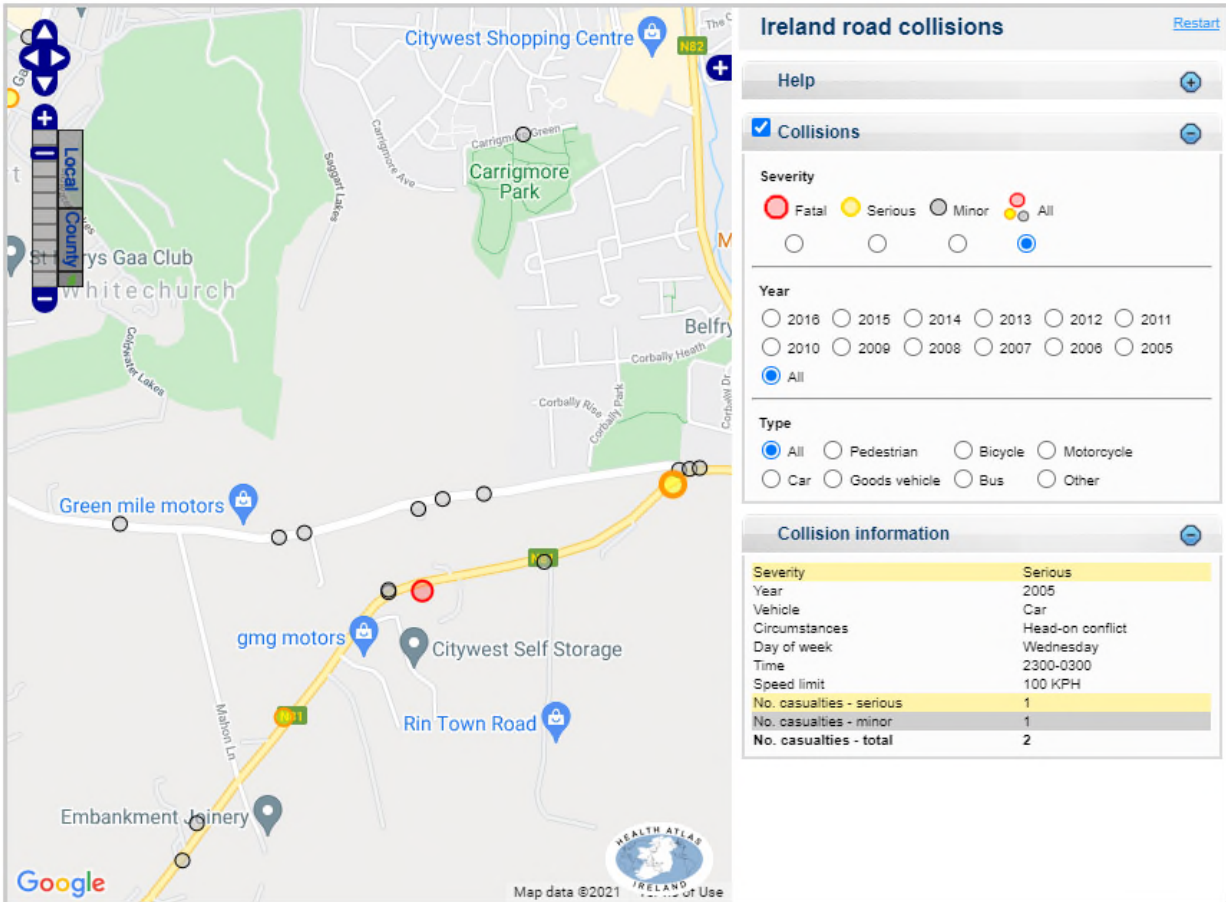
The Road Safety Authority’s website shows that in the 12-year period 2005 to 2016 that there were a number of minor injury collisions recorded along Boherboy Road. There was one serious injury recorded at, or close to, the N81 junction which had a primary collision type of, head-on.

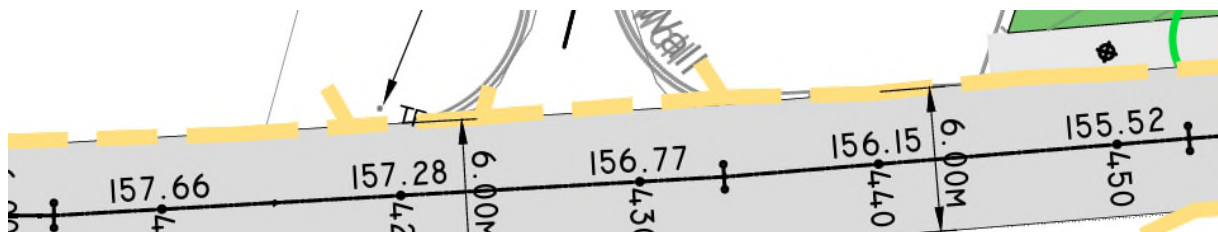
Drawing p200107X-PIN-XX-Dr-D-0011-SI Rev P01, Boherboy Road, Chainage 70 to chainage 440.

There is a discontinuity in the footway provision on Boherboy Road between chainage 70 and Chainage 440 due to land ownership constraints. The road is being realigned and widened to have a constant cross sectional width of 6m. There is a risk that the proposed development will lead to an increased usage of Boherboy Road by pedestrians wishing to travel to Saggart village, leading to a higher likelihood of a collision with vehicular traffic. It is proposed to provide a raised rib line along the section without a footway. There is a risk that the raised rib line will not be provided due to the noise effects on local residents.

It is recommended that the carriageway be marked narrower than 6m and that the verge be provided flat and level with the carriageway so that pedestrians will have refuge. In areas of wider road bed, vegetation should be cleared to provide additional refuge.

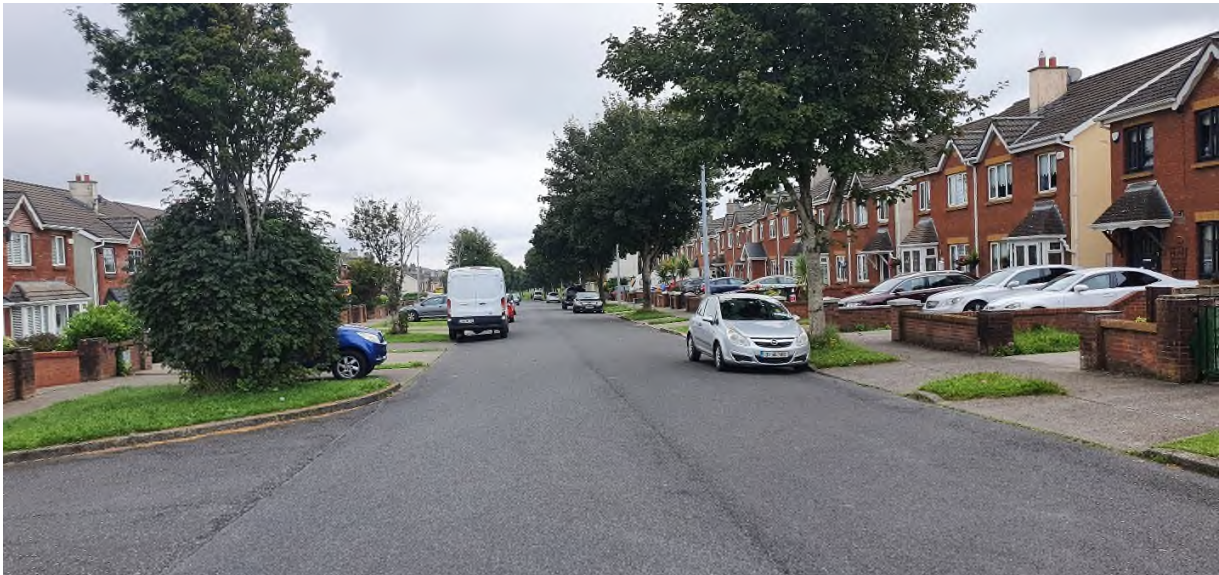
Drawing p200107X-PIN-XX-Dr-D-0013-SI Rev P01, Corbally Heath & Carriagmore Green.

It was observed during the site visit that there is extensive on-street parking on Corbally Heath & Carriagmore Green to which the proposed development will be linked for vehicular traffic. Whilst the on-street parking provides traffic calming effects in the current scenario this may result in driver frustration and side-impact collisions as these routes become more intensely used when the development is fully occupied.

It is recommended that an assessment of the amount of on-street parking be undertaken along with the current under usage of on-curtilage parking to establish if the problem as described above will manifest itself.

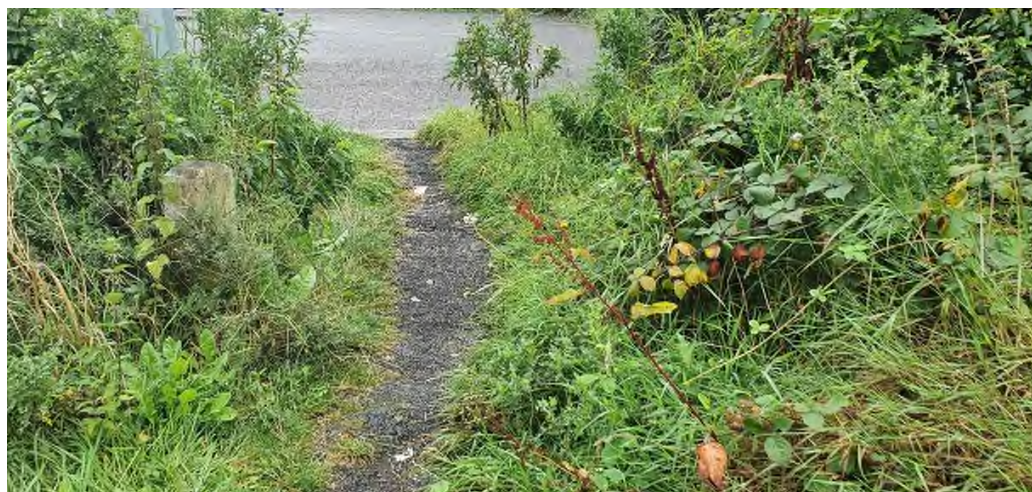
Drawing p200107X-PIN-XX-Dr-D-0033-SI Rev P01, Carraigmore.

There is an existing pedestrian desire line from Carraigmore Green to Carraigmore Avenue. The demand will increase when the proposed development is fully occupied and this pedestrian desire line should be facilitated as an alternative pedestrian route to Saggart village rather than Boherboy Road.

It is recommended a pedestrian link to Carraigmore Avenue be provided.

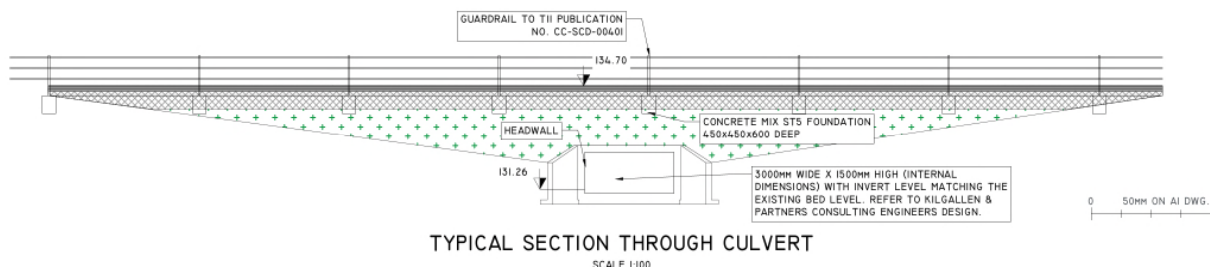
Drawing p200107X-PIN-XX-Dr-D-0034-SI Rev P01, Culvert protection.

A railing in accordance with TII Standard Detail CC-SCD-00400 has been referred to on the drawing as containment at the bridge structures. It is unclear if this will provide adequate containment to errant vehicles.

It is recommended a risk assessment be carried out to ensure sufficient containment is being provided at the bridges/culverts.
