**Title: QUALITY AUDIT  
INCLUDING ROAD SAFETY AUDIT (Stage 1)  
For;  
Proposed Residential Development and Road Upgrade,  
Boherboy, Saggart, Co. Dublin.**

**Client: Pinnacle Consulting Engineers.**

**Report reference: 1151R01**

**VERSION: FINAL (February 2022)**

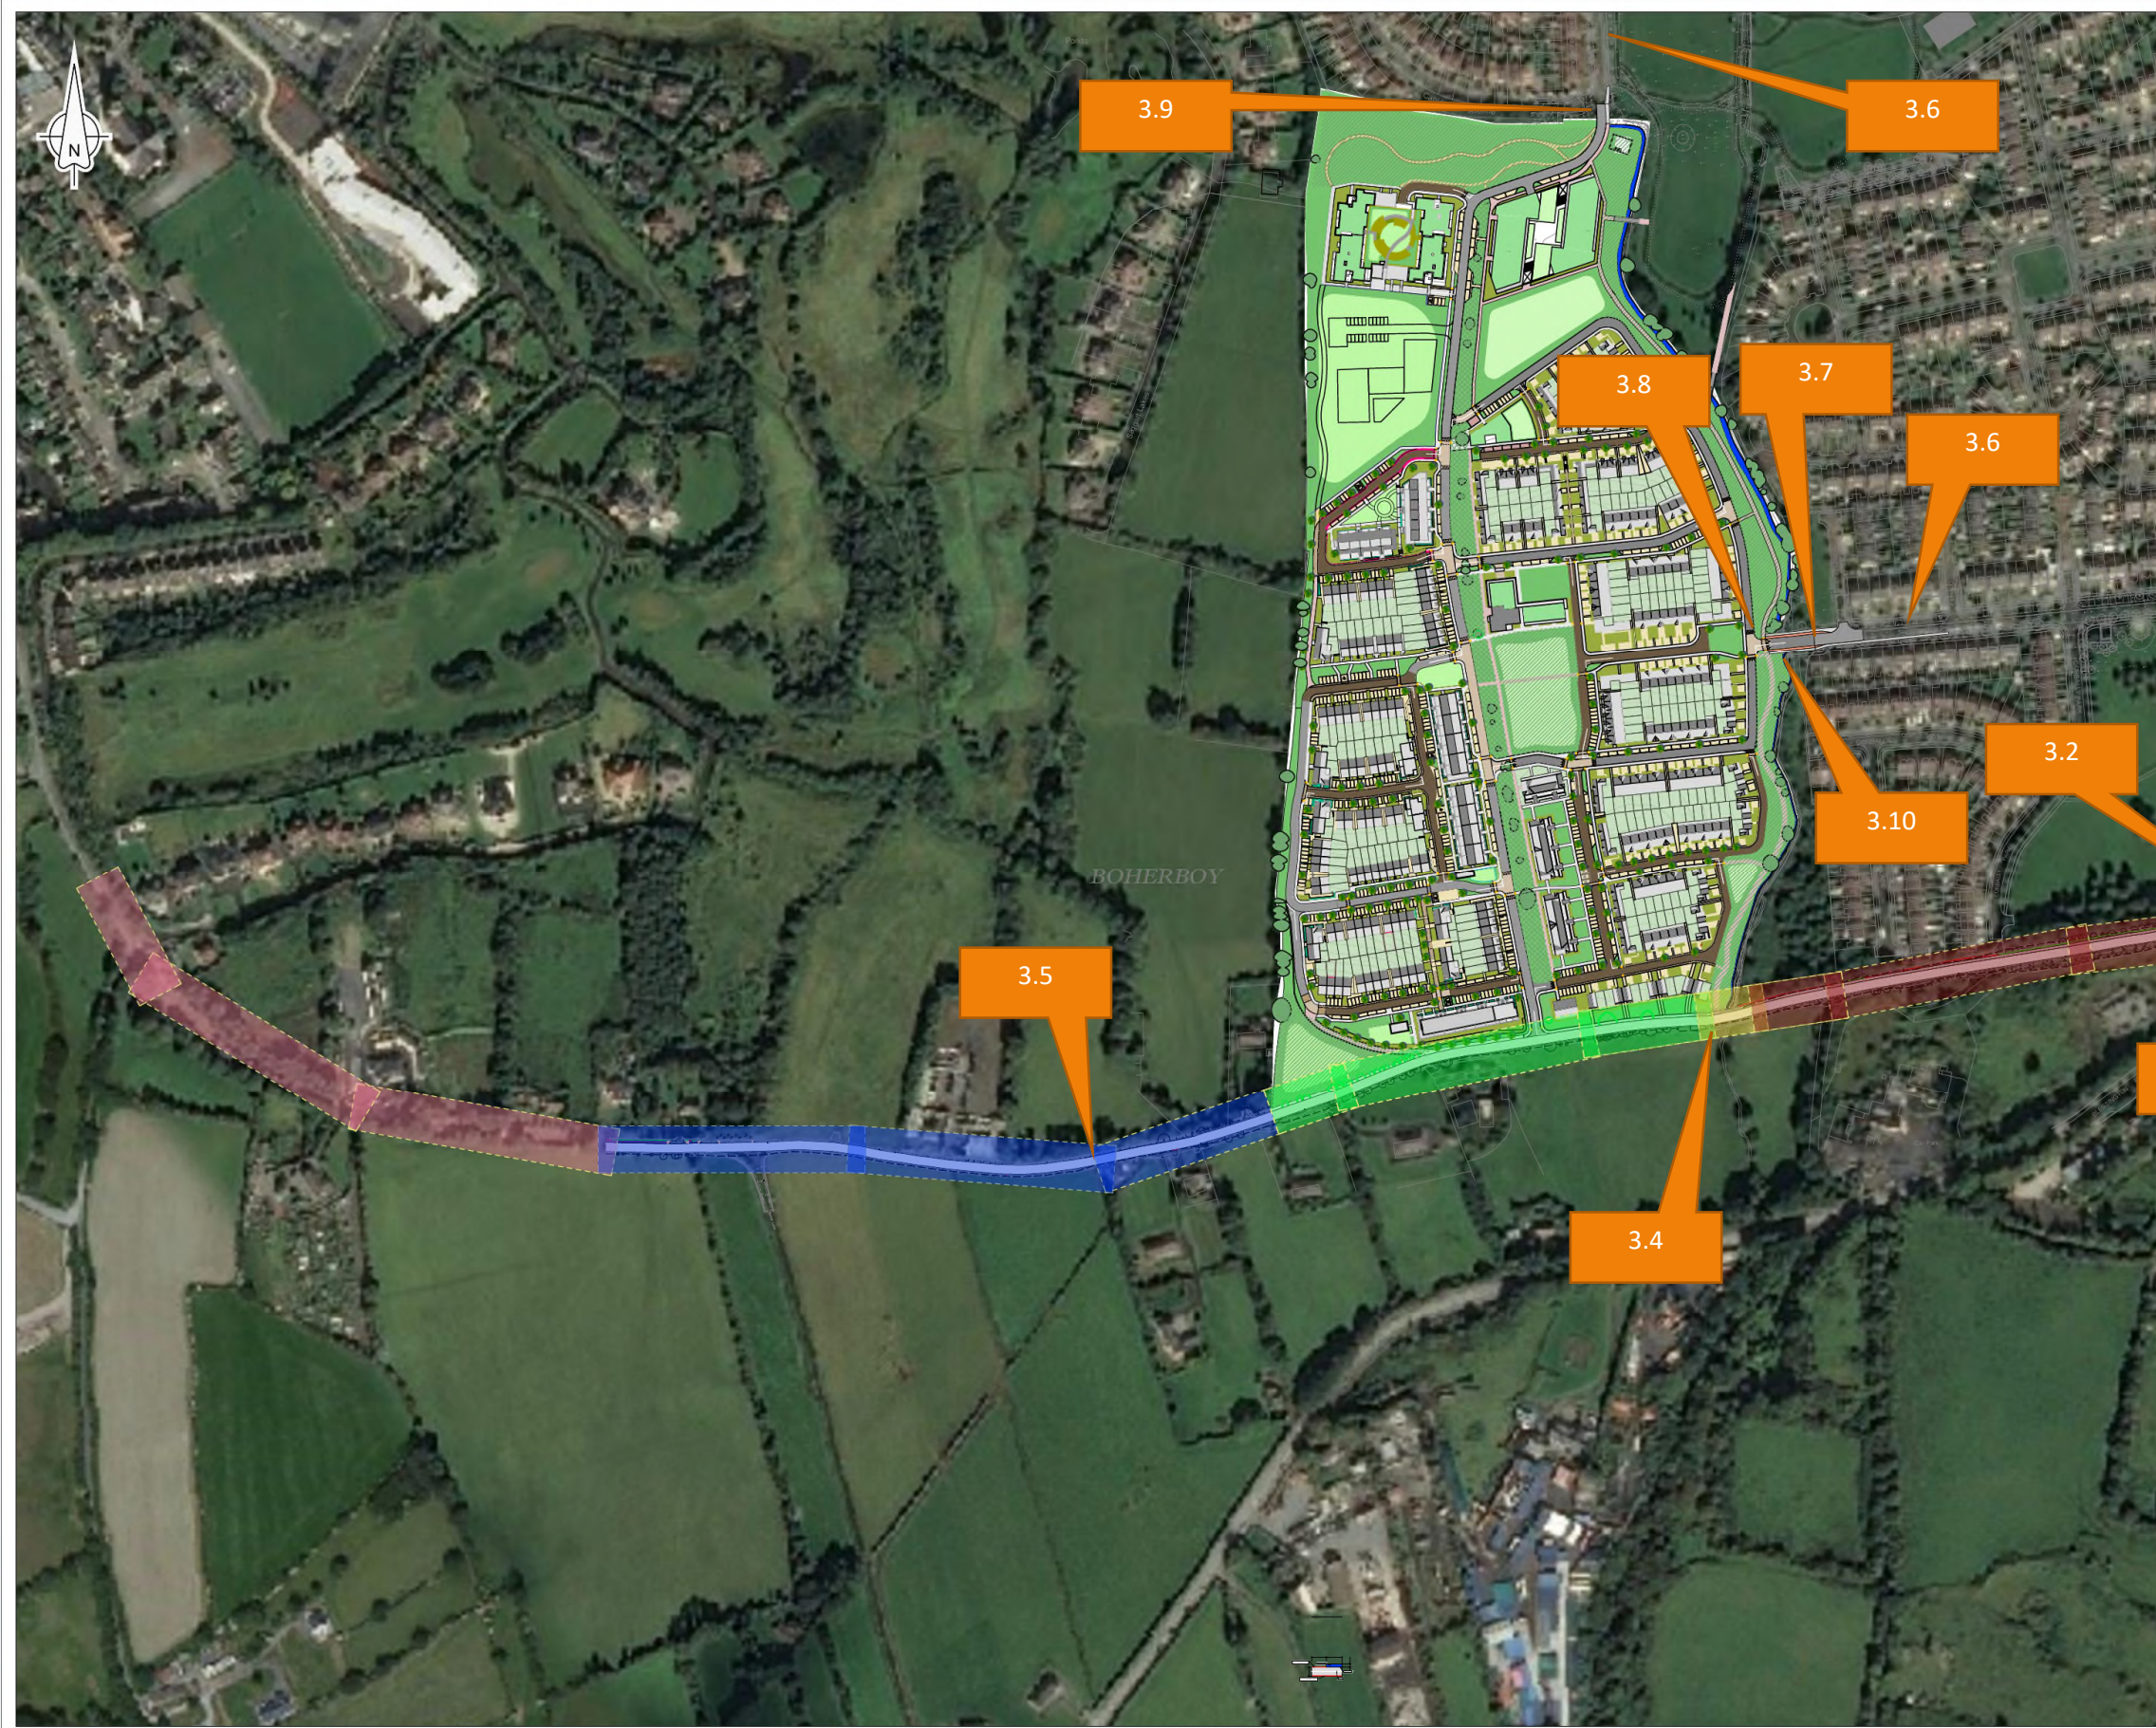
### Problem Location Plan.

There is a risk of overshoot of the stop line at the N81 junction for eastbound drivers on Boherboy Road. This could lead to rear end or side-impact collisions with eastbound traffic on the N81. In addition the proposed straight ahead arrow may suggest drivers have priority to proceed.

It was observed during the site visit that there is extensive on-street parking on Corbally Heath & Carriagmore Green to which the proposed development will be linked for vehicular traffic. Whilst the on-street parking provides traffic calming effects in the current scenario this may result in driver frustration and side-impact collisions as these routes become more intensely used when the development is fully occupied.

It is recommended that a buildout be provided at the existing footpath into which some signage or other feature be provided to alert drivers that it is not a through route and which will force drivers to approach the N81 at a less acute angle. The straight ahead arrow should be removed.

It is recommended that a solid island be provided in lieu of the hatched area.

It is recommended that a gateway/transition type feature be provided at the 60/80km/hr transition on the N81 to ensure vehicle speeds at the junction are at or below the speed limit of 60km/hr.

It is recommended that the carriageway be marked narrower than 6m and that the verge be provided flat and level with the carriageway so that pedestrians will have refuge. In areas of wider road bed, vegetation should be cleared to provide additional refuge.

It is recommended that an assessment of the amount of on-street parking be undertaken along with the current under usage of on-curtilage parking to establish if the problem as described above will manifest itself.

It is recommended that the short section of cycle track be omitted.

It is recommended that a pedestrian crossing similar to the south side of the junction be provided.

It is recommended a pedestrian link to Carraigmore Avenue be provided.

It is recommended a risk assessment be carried out to ensure sufficient containment is being provided at the bridges/culverts.
